Harpster Trip Summary - August 2, 2017

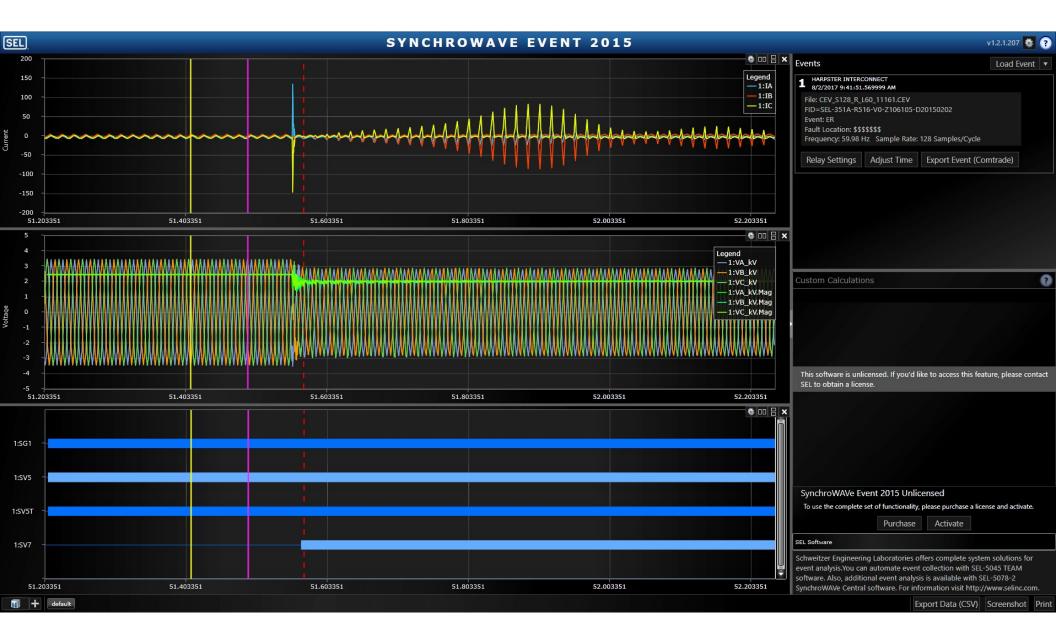
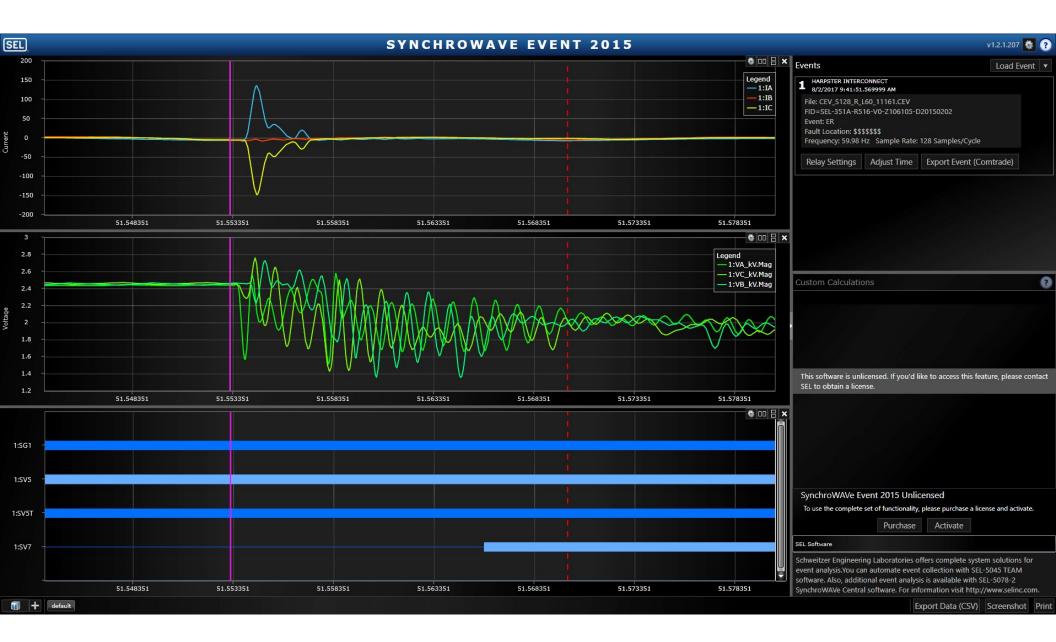
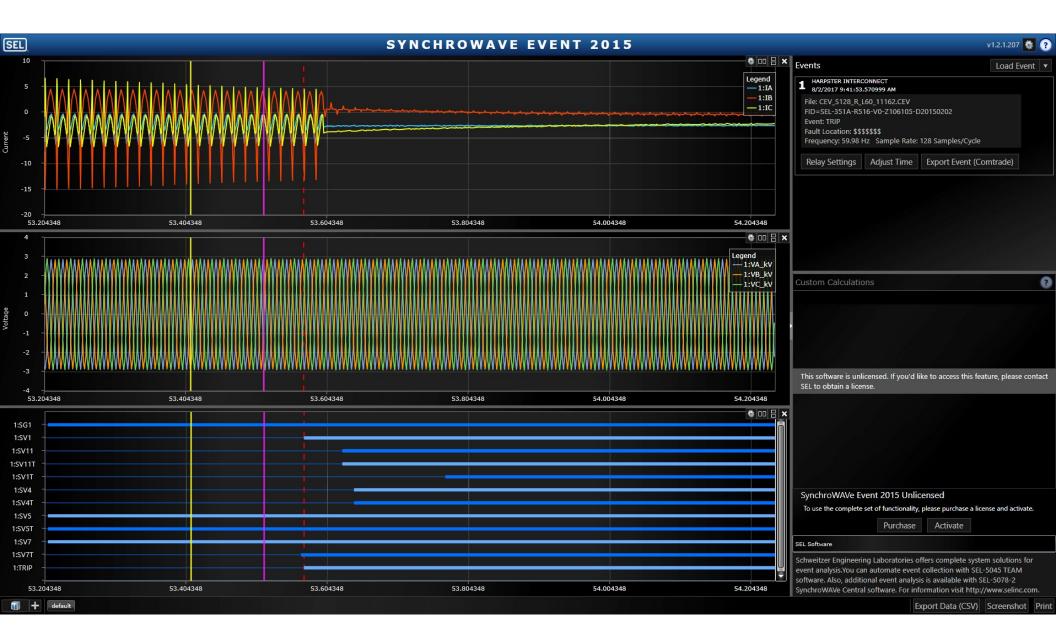
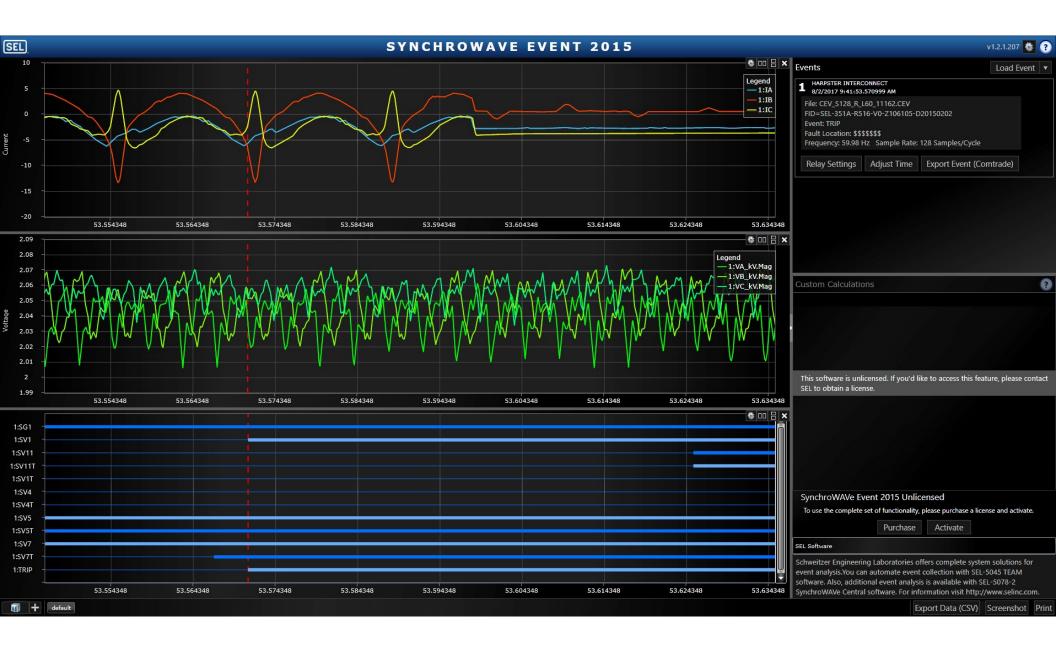
- Before reviewing the fault files we need to calculate the P2P under-voltage specific to the Harpster grid, grid voltage is 4.16kV.
 - $O Voltage per Phase = \frac{4.16kV}{\sqrt{3}} = 2.40kV$
 - Grid specific under-voltage $\rightarrow \left(\frac{105.60}{120.00}\right) * 2.40kV = 2.11kV$
- Phase A drops below the 2.11kV threshold first followed by Phase B and Phase C.
- SV7 is triggered about 0.01 seconds after Phase A drops.
- All three phases oscillate dramatically for about 0.02 seconds and settle around 2kV.
- SV7 runs for 2 seconds (SV7PU = 120 cycles) before tripping, voltage remains around 2kV.

- Extending PU will likely not fix the issue, PU change from 60 to 120 did not and voltage doesn't increase above 2.11kV threshold during 60 or 120 cycles.
- Decrease under-voltage relay setting to absolute min
 - o Absolute min = 1.36kV
 - $0 27P2P = \left(\frac{1.36kV}{2.40kV}\right) * 120 = 68.00V$
- Decrease under-voltage relay to just below settling voltage
 - Settling voltage = \sim 2.00kV \rightarrow Use 1.90kV
 - \circ 27P2P = $\left(\frac{1.90kV}{2.40kV}\right) * 120 = 95V$
