ONE ENERGY DRONE INSPECTIONS

THE DRONE INSPECTION PROGRAM

EMERGING TECHNOLOGIES IN BLADE INSPECTIONS

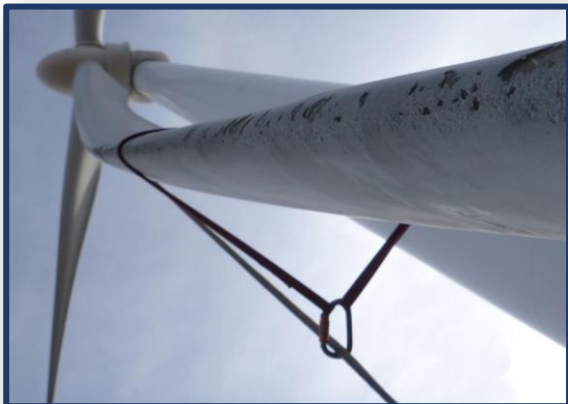
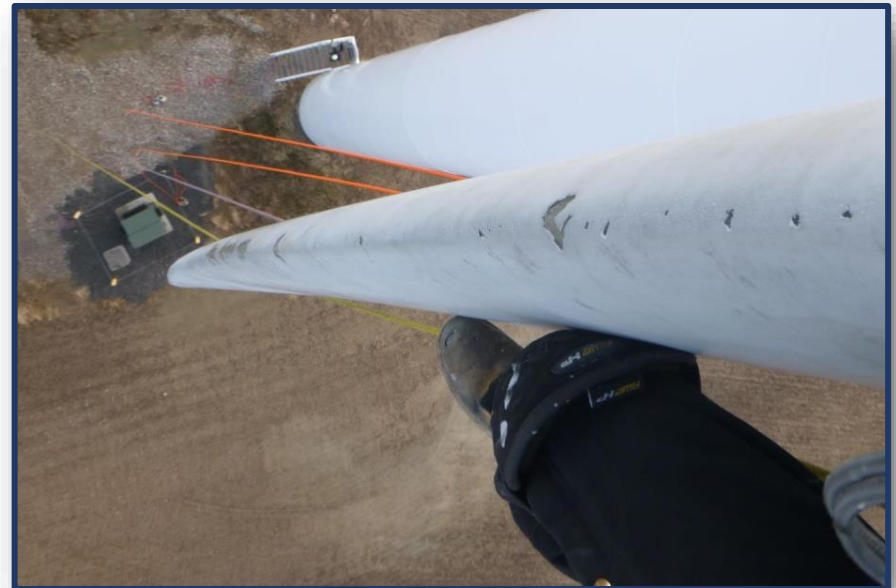
BLADE INSPECTIONS – BEFORE

- Physical rappelling with Rope Partner LLC to hang off nacelle and move down blades to get up close photos.
- Slow, expensive, & hazardous. Had to re-ascend and retract ropes before moving to the next blade.
- Binocular & camera inspections were impractical.

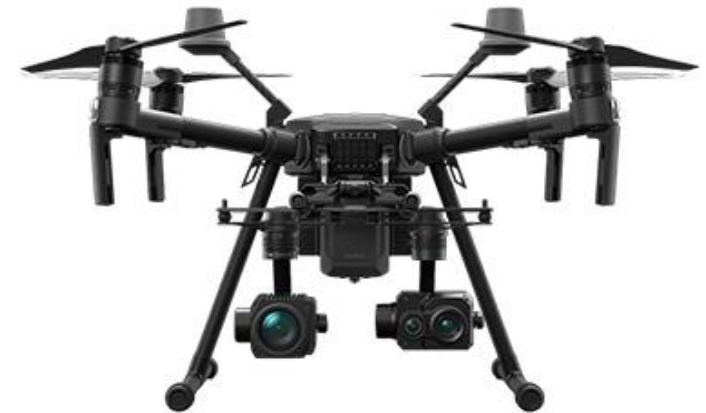
ONE ENERGY DRONE OPERATIONS

- One Energy's drone inspection program utilizes UAVs capable of:
 - Prolonged flight times up to 30 minutes
 - High definition, high zoom imaging and video platforms
 - Up to 30x magnification
 - Forward and downward obstruction ultrasonic sensing capabilities
 - GPS-reference and real-time kinematic flight stabilization
- Matrice 210 V2 model was in service for 5 years
- Currently seeking a replacement

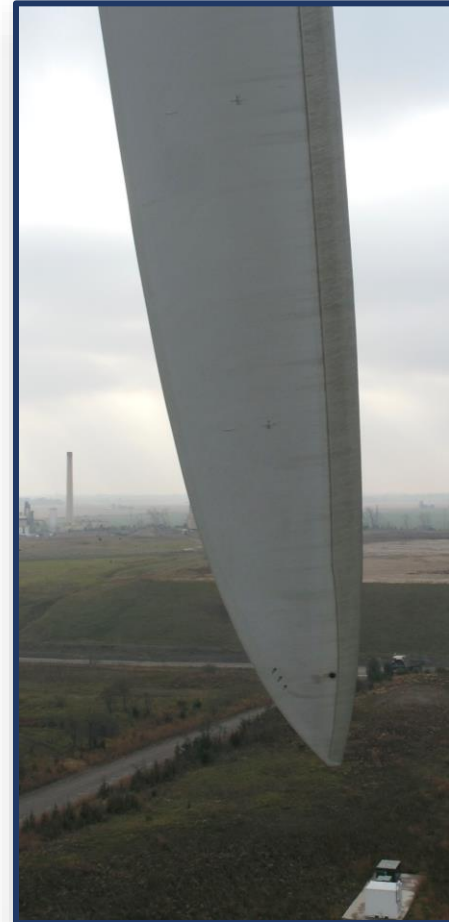
BLADE DAMAGES: NONE

- Leading Edge Protection (LEP) completely intact
- No wear to the gel coat

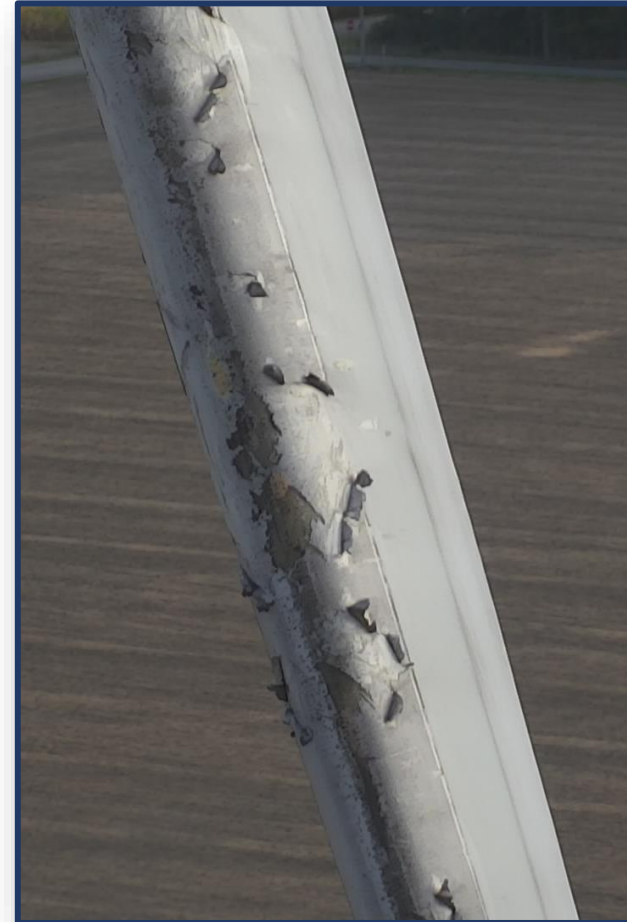
BLADE DAMAGE: MODERATE

- Significant LEP tearing and fraying over span of leading edge
- Areas of low severity erosion to underlying gel coat
- Holes in LE present of <1 in. diameter.

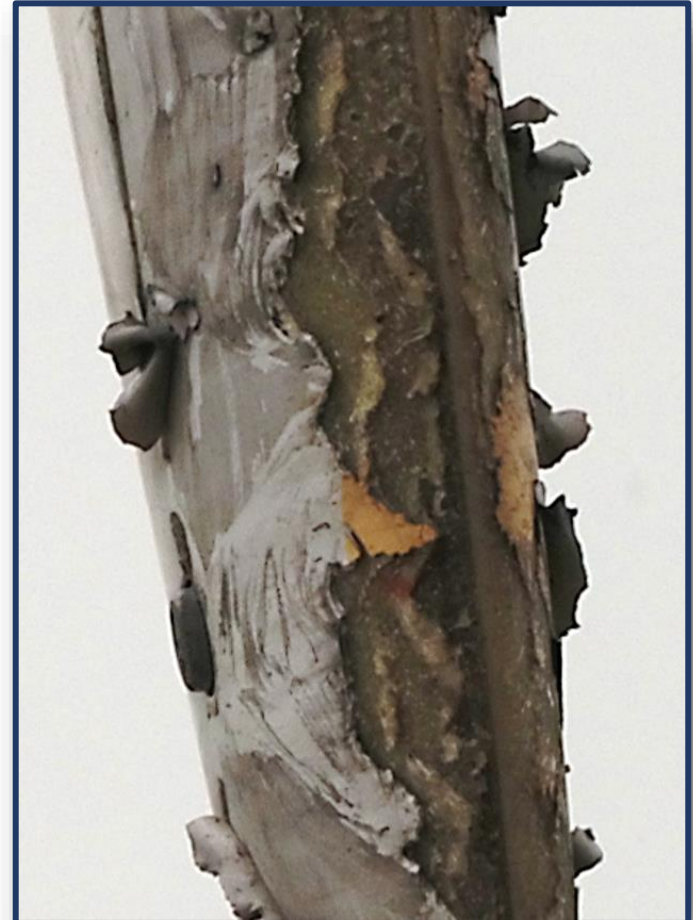
BLADE DAMAGE: MAJOR

- LEP completely eroded
- Underlying fiberglass or balsa wood filler exposed
- Holes, gashes, cuts, crushing damage visible on blade
- Split blade tips
- >50% of VG fins dislodged

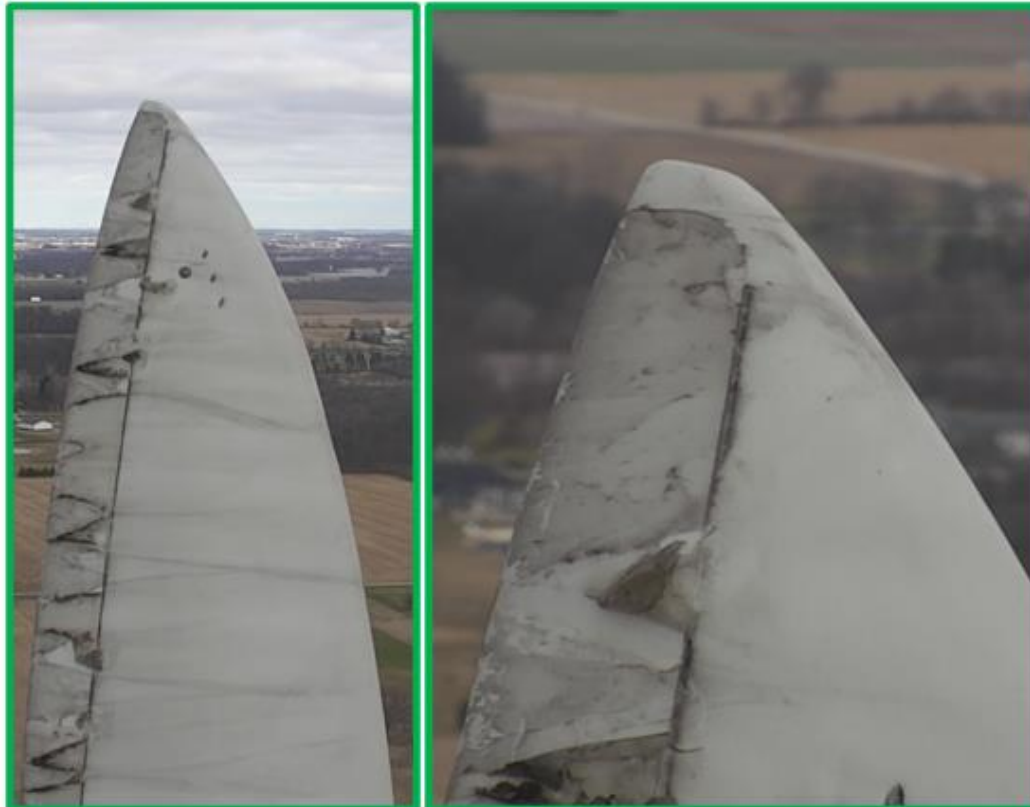
SUCTION SURFACE

BLADE 2: GREEN

Approx ¼ of LEP exhibiting heavy fraying; first ¼ in passable condition. Start of LEP also peeling. 35 bent/broken VG fins, 31% of total.

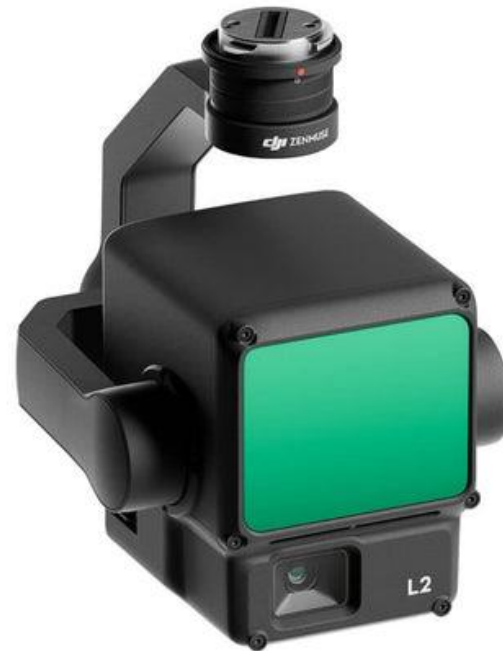
DRONE LIDAR CAPABILITIES

- Drones can now be equipped with LIDAR scanners
- Capable of gathering 3D point-maps of objects in real time
- Use case include mapping major damages to blades in case of gouges/holes, or scouting for very small holes unseen by observer during inspection process

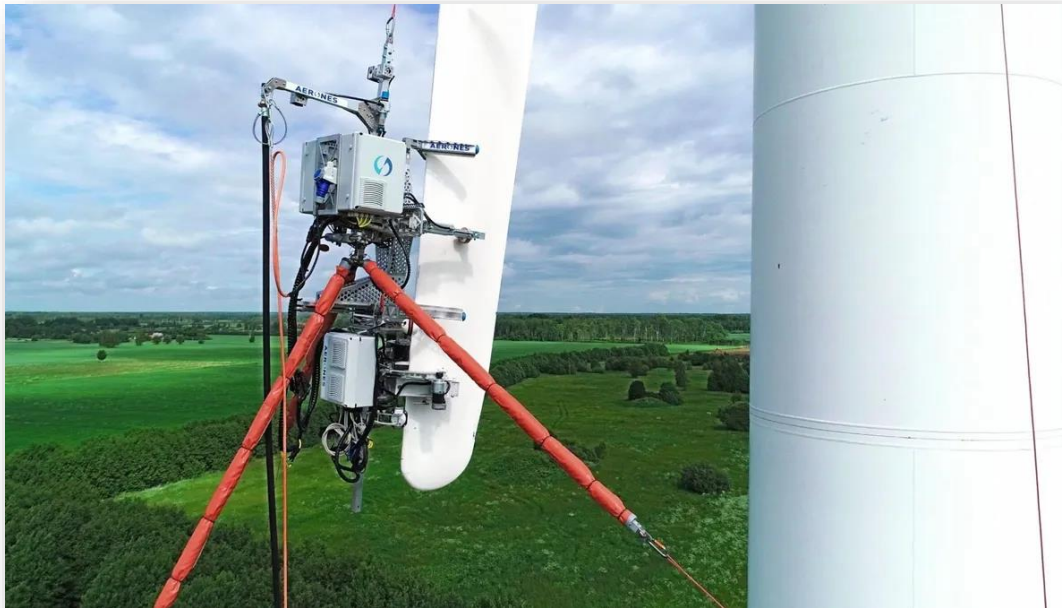
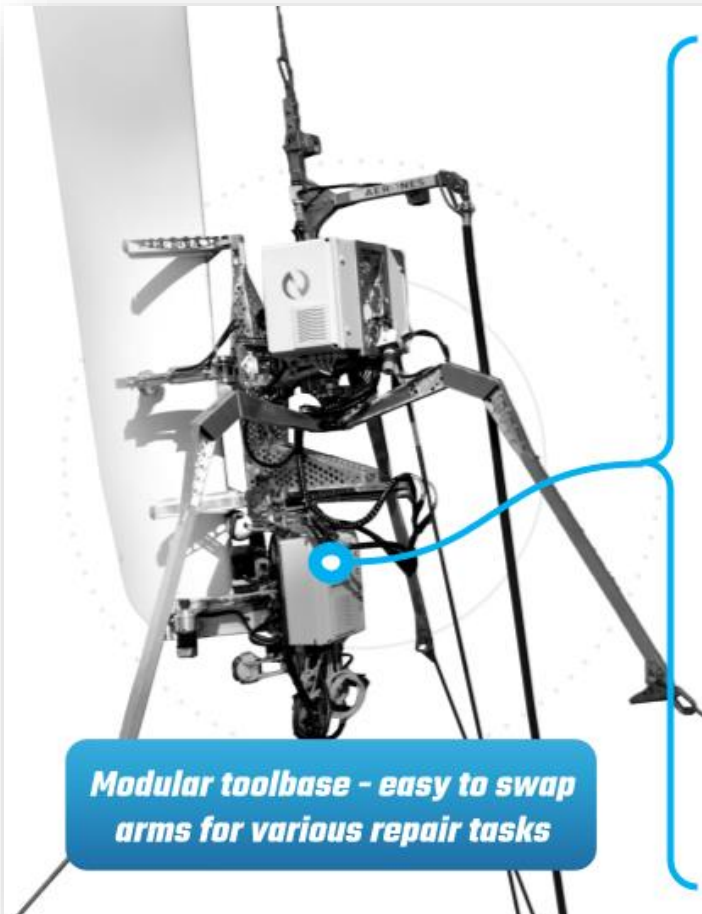
AERONES

- <https://aerones.com/>
- Company that provides ground-based robotic blade inspection, washing, scanning, coating, LEP application, and repairs

Modular toolbase - easy to swap arms for various repair tasks

Inspections	Down Conductor GAP Scanning	Ultrasound Scan	Drainage Cleaning	
LPS Conductivity & High Voltage Test				
Cleaning	Blade Cleaning	Tower Cleaning	Nacelle Cleaning	
Maintenance	Leading Edge Cleaning	Ice-Phobic	LPS Oxidation Cure	
Repair	3m Tape Remover	Surface Prep (Sanding, Grinding)	Filler	Promoter And Protection Coating

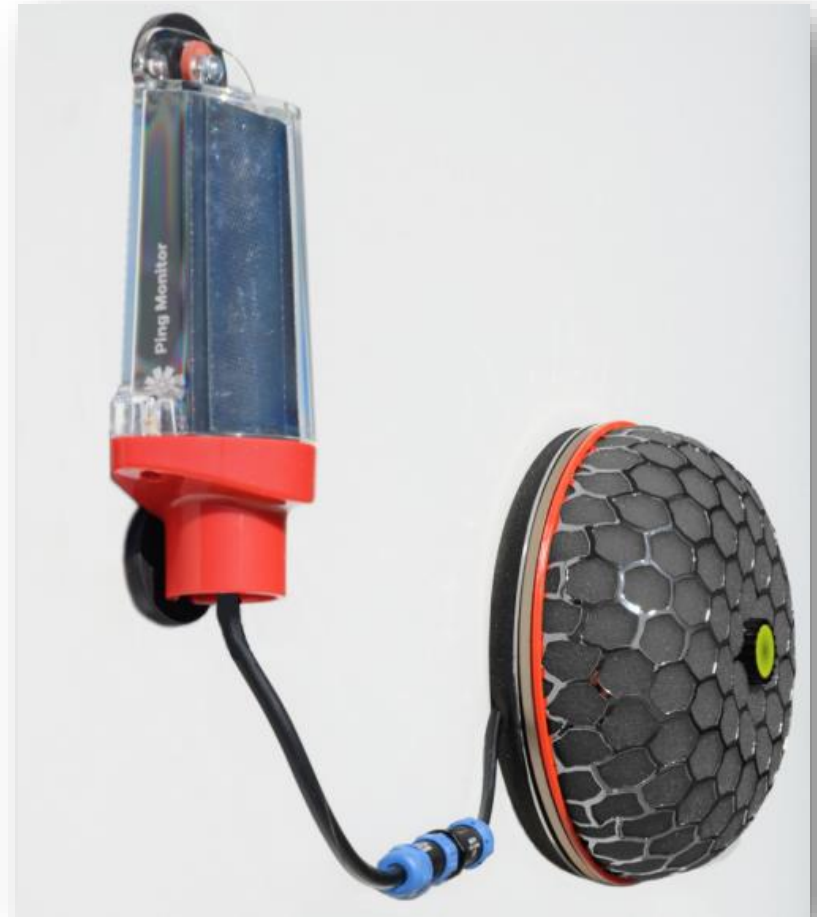
PING MONITOR

- Formerly used by OE
- Data gathered from sonic monitoring system was unusable by O&M
- External microphone monitoring systems are a developing field
 - While flawed now, neural network audio processing technology may allow for more advanced early warnings

- Magnetically mounted microphone array at base of turbine
- Solar powered
- Received ambient noise made by turbine blade air displacement
- Returned a blade condition value from 1 to 5 with 1 being in good condition and 5 being poor condition

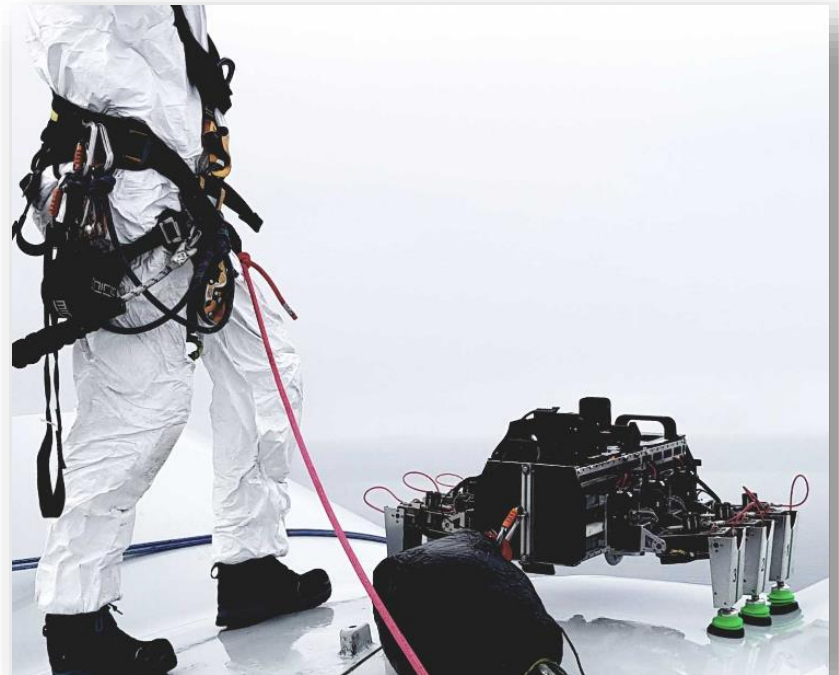
BLADEBUG AND OTHERS

- <https://bladebug.co.uk/>
- Robotic suction cup blade crawlers to utilize up close ultrasonic structural examination and other nondestructive testing methods.
- Rope access teams are still required

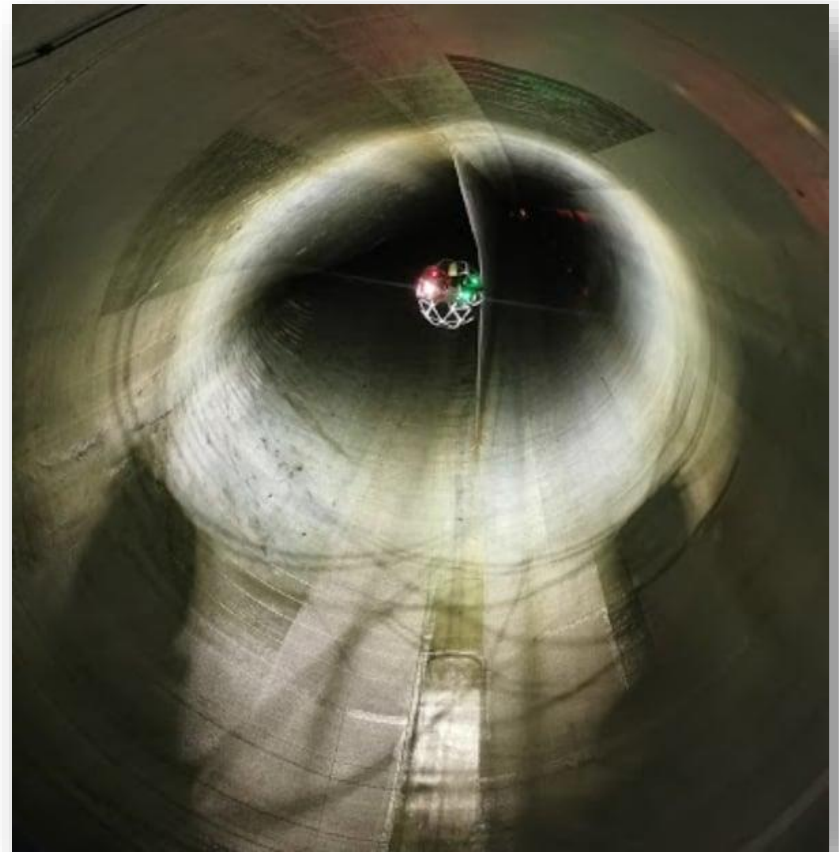
CONFINED SPACE DRONES AND INTERNAL BLADE INSPECTIONS

- Development in confined space, collision-tolerant “cage drones” allows for internal views and inspections of blades.
- Otherwise-unseen damage to stringers and spars that could pose structural threats to blade could be detected early

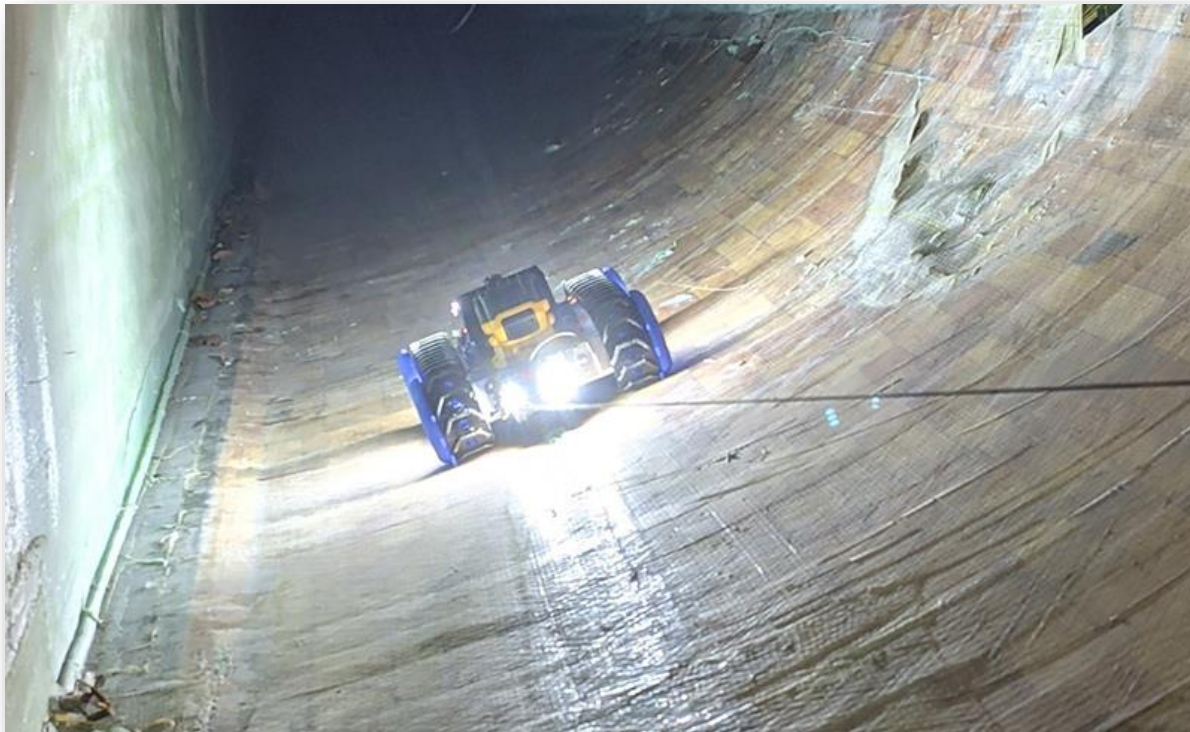
INTERNAL BLADE INSPECTIONS

- Crawler-type drones can be used in situations where blades can be held horizontally are also options for internal inspections

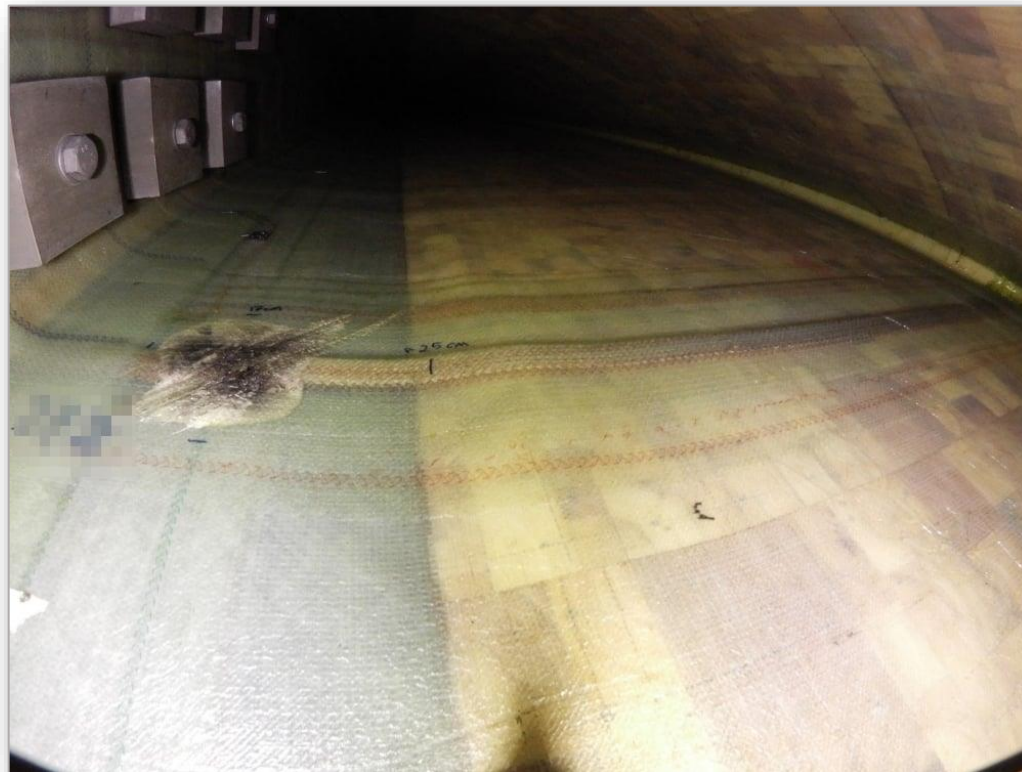
LPS CABLES

- Damage to lightning protection system cables could pose critical fire and structural hazard to blade and turbine integrity
